29. Site 29 at RM 339.3 LDB (Pool 21)

30. Site 30 at RM 339.3 RDB (Pool 21)

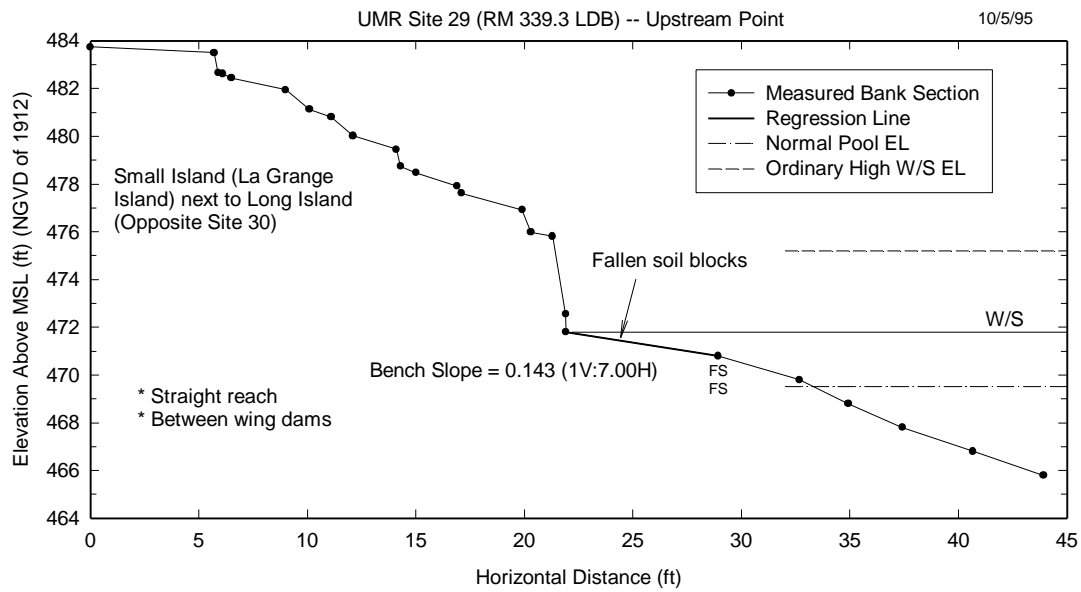
Figure 7-102 Bank section measured at Site 29 upstream point

Causative factors for bank retreat at this site include piping, flood-flow erosional oversteepening and rapid recession and piping-initiated failures, block failures, and wave and flow rework-transport of failed soils and recently deposited sediments within bench areas. This site is characterized by a combination of Types A, B, and C.

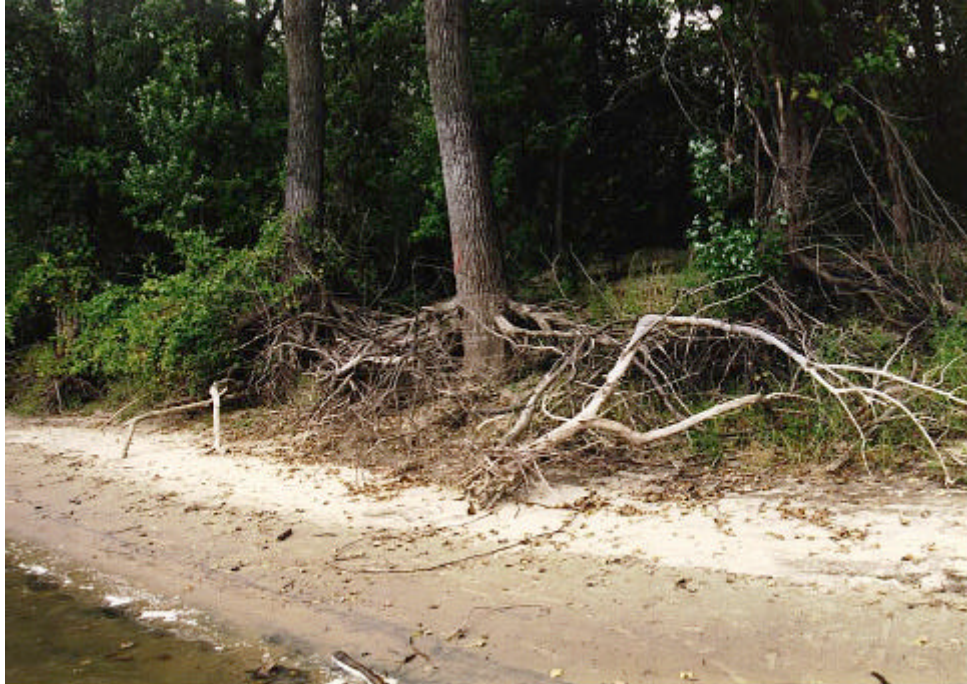
Photo 7-77 An upstream view of Site 31 midpoint

with some medium silt (MST). Denmark Island is covered with sand deposit from the Great Flood of '93. No geomorphic soil core samples were taken at Site 31.

Causative factors for bank retreat at this site include flood-flow erosion, piping-related collapse, and wave and flow rework-transport of failed soils and recently deposited silty sand which covers bench areas. A combination of Types D and E characterizes this site.

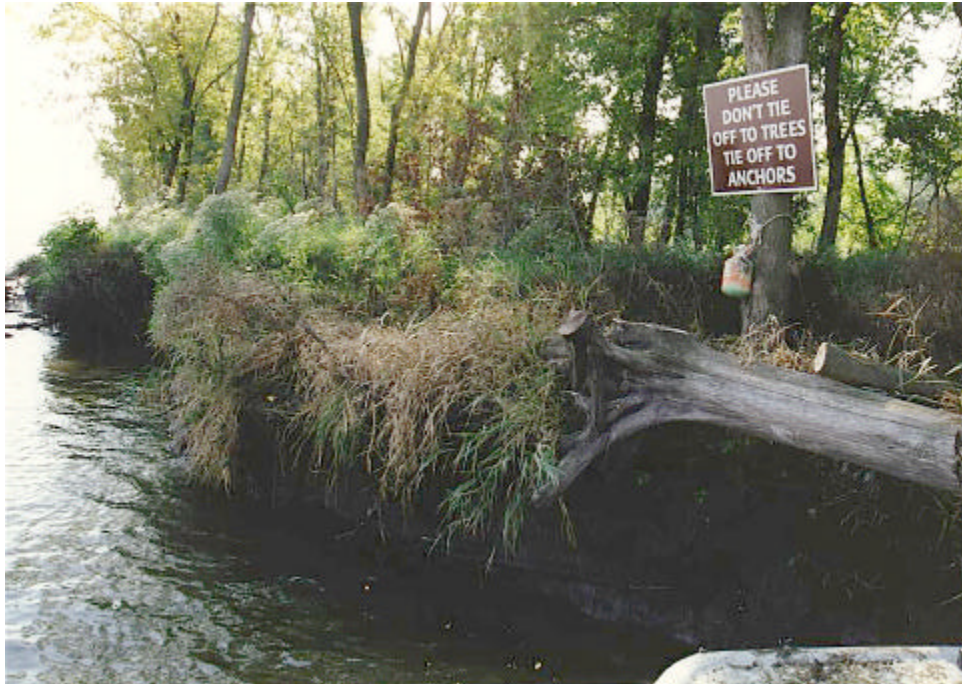
Photo 7-79 A downstream view of Site 32 midpoint

Causative factors for bank retreat at this site include flood-flow erosional oversteepening and subsequent failures, bench-area rework-transport of failed soils and recently deposited sediments by waves, and barge-mooring activities. Evidence of erosion due to traffic-generated waves and turbulence, and barge mooring exists at this site. Type A is the most representative classification for Site 32.

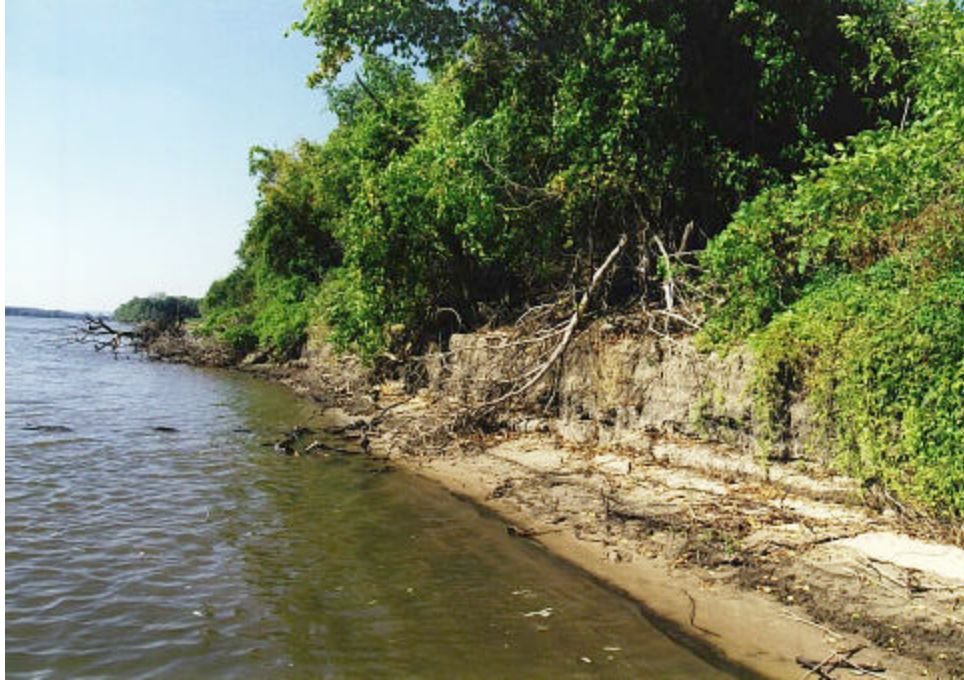
One bank section taken at the midpoint is shown in figure 7-111. The bank soils are primarily silt (VFST-CST). The scarp is almost vertical and contains numerous piping features. Failed soil blocks had accumulated at the toe of the scarp.

Photo 7-81 An upstream view of Site 33 midpoint

Causative factors for bank retreat at this site include piping and flood-flow related erosion and block failures, and wave and rework-transport of failed soils and recently deposited sediments from bench and berm areas. Type A characterizes this erosion site.

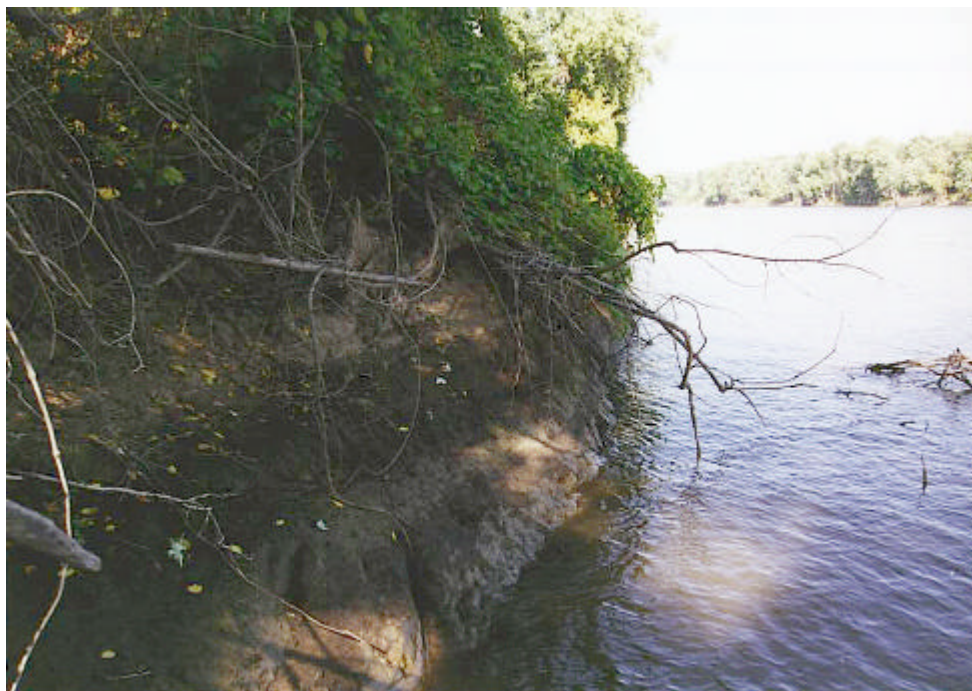
with minor piping, about 8 ft high, indicates that erosional oversteepening and collapse occurred during the Great Flood of '93 and the floods of

Photo 7-83 An upstream view of Site 34 midpoint

Causative factors for bank retreat at this site include flood-flow erosion and rapid recession failures, and minor piping and collapse. There is potential for wave erosion of failed soil and recently deposited sediments which cover bench and berm areas. Type A is the best bank type for this site.

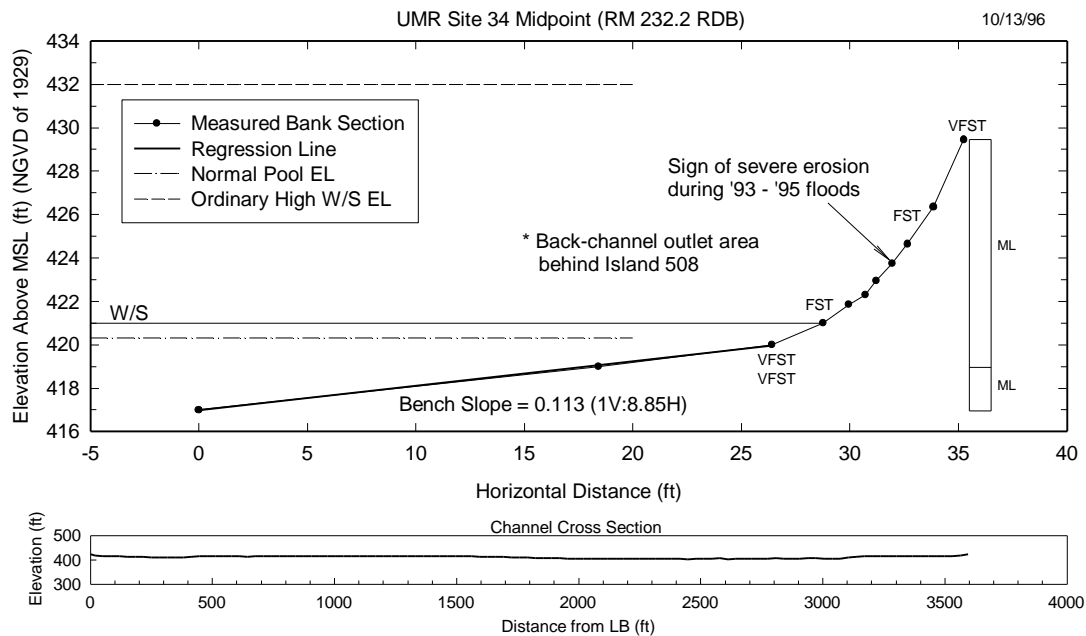
1994 and 1995. Drawdown generated by the transiting of 16 loaded upstream-bound barges was measured as about 0.25 ft.

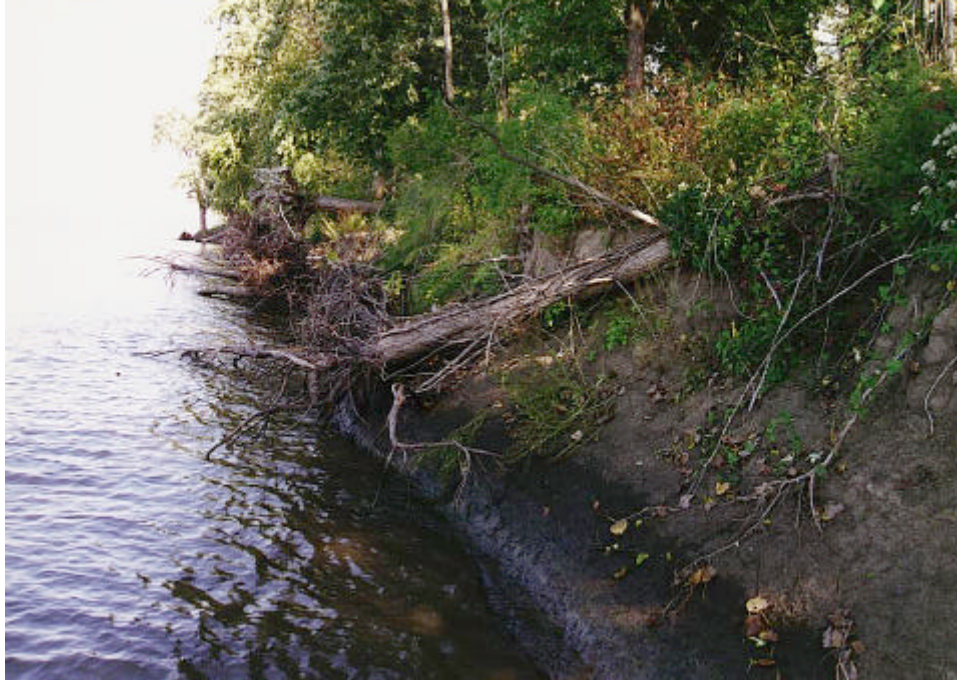
Photo 7-85 A downstream view of Site 35 midpoint
